# WOOD DESTROYING PESTS AND ORGANISM INSPECTION REPORT

Building No. <b>973</b>	Street <b>Redmond Avenue</b>	City <b>San Jose</b>	ZIP <b>95120</b>	Date of Inspection <b>7/28/2009</b>	Number of Pages <b>Page 1 of 8</b>
----------------------------	---------------------------------	-------------------------	---------------------	----------------------------------------	---------------------------------------

HomeGuard Rpt #: **134510**

General Description: <b>Two story, single family wood framed residence with stucco and wood exterior.</b>	Inspection Tag Posted <b>Garage</b> Other Tags Posted <b>Ken Carrer 6/09</b>
-----------------------------------------------------------------------------------------------------------	---------------------------------------------------------------------------------

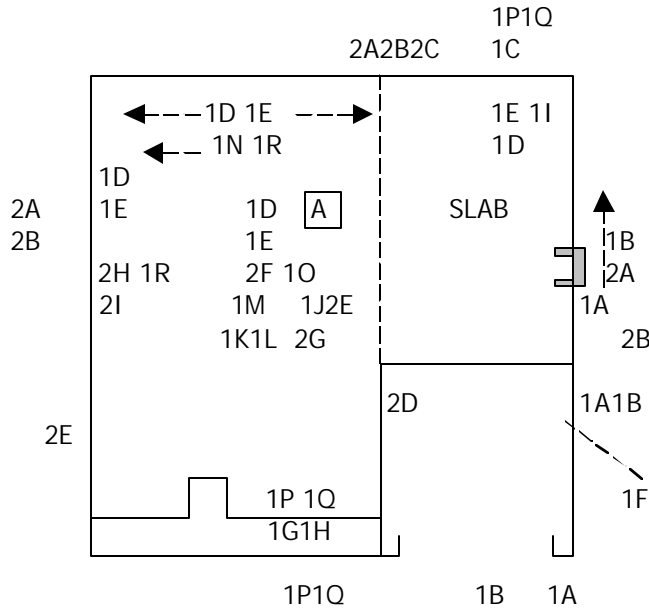
**Key to Items on diagram: [1] Section 1 Items [2] Section 2 Items [3] Unknown Further Inspection Items**

**1A.** FINDING: Fungus damage was noted to the roof eaves as indicated on the diagram.

**1B.** FINDING: Fungus damage was noted to the rafters as indicated on the diagram.

**2A.** FINDING: Minor stress cracks were noted in the exterior stucco as indicated on the diagram.

RECOMMENDATION: Remove and replace the damaged wood members to correct this condition. This bid includes replacement of the roof covering if disturbed by our repairs. The guarantees on the roof covering are limited to the areas where the work was performed. It will be the owner's responsibility to reinstall the gutters upon completion of our roof repairs if necessary.

RECOMMENDATION: Remove and replace the damaged wood members to correct this condition. This bid includes replacement of the roof covering if disturbed by our repairs. The guarantees on the roof covering are limited to the areas where work was performed. It will be the owner's responsibility to reinstall the gutters upon completion of our roof repairs if necessary.

RECOMMENDATION: The owner is to seal these areas and maintain the exterior paint.
